Draft Environmental Assessment

Stream Bank Protection at Big Delta State Historical Park

Tanana River near Big Delta, Alaska

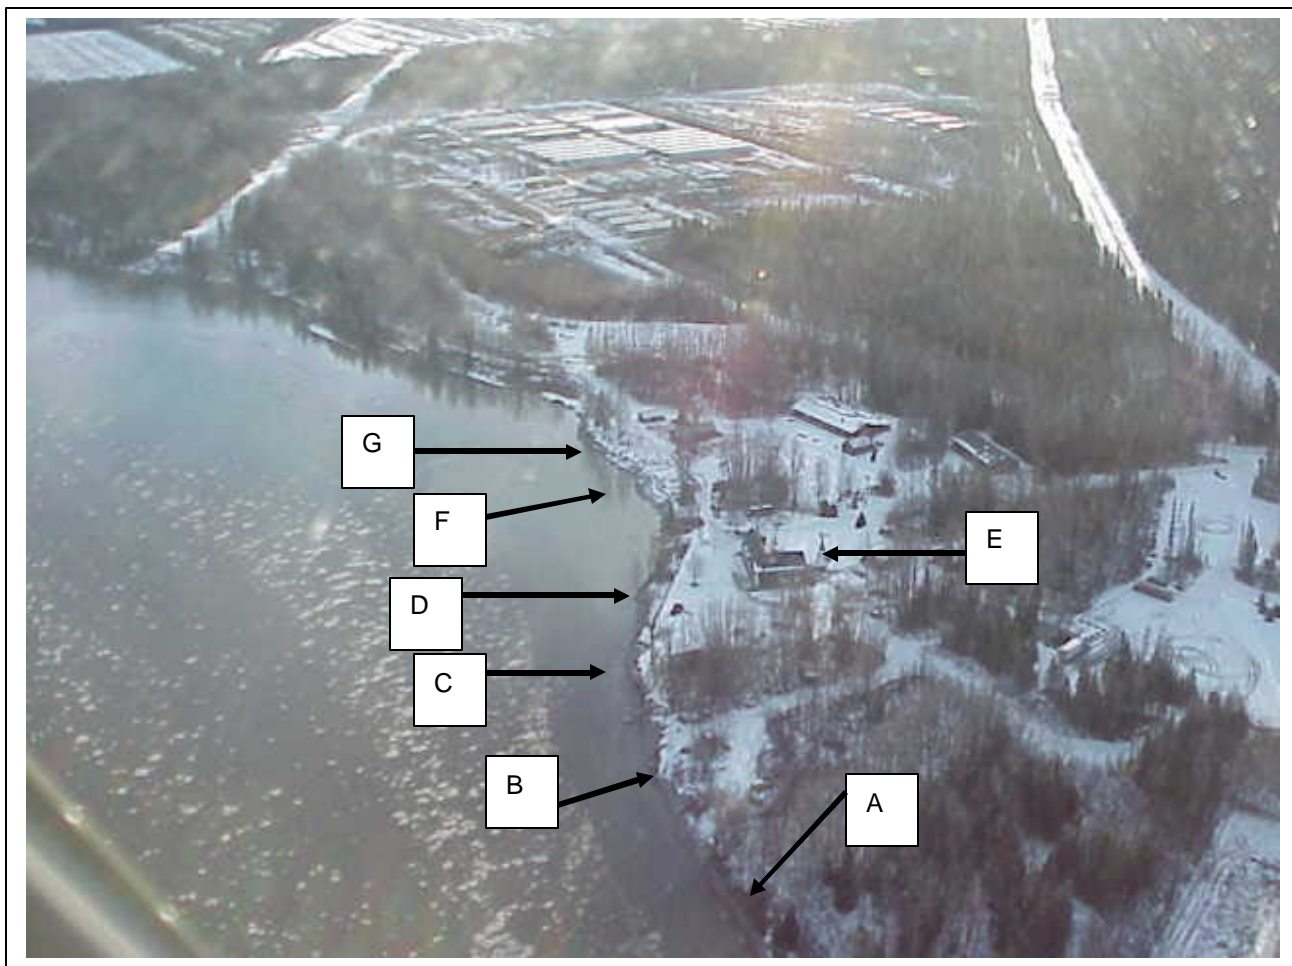
Figure 2: Aerial oblique photo, looking upstream at Big Delta State Historical Park

- Point A: Bank downstream of private property (downstream of Big Delta State Historical Park)
- Point B: Private property downstream of Big Delta State Historical Park
- Point C: Boat launch, lower section of Park property in front of Ferryman's cabin
- Point D: Point in front of Rika's Roadhouse Building
- Point E: Rika's Roadhouse Building
- Point F: Alcove upstream of Rika's Building with shallow shelf and log crib ferry dock structure
- Point G: Point upstream of Rika's Roadhouse Building

Big Delta State Historical Park is situated on the outside bank of a wide bend on the south side of the Tanana River, a short distance upstream from the confluence of the Tanana and Delta Rivers (Figure 1). The nearby community of Big Delta is located along the Richardson Highway about a half mile from the Park, and 73 miles southeast of Fairbanks, Alaska. The Park consists of numerous restored historic buildings, including Rika's Roadhouse, and is a popular stop for tourists. The State of Alaska and the Park concessionaire have spent a significant amount of time and money in recent years to restore the historic buildings and construct improvements to meet visitor demands on the Park. Eight structures in the Park are listed as the Big Delta Historic District on the National Register of Historic Places. The Park is a key statewide tourism infrastructure facility with over 34,000 visitors annually. The Park is also a Type A "Flagship" highway wayside with full service visitor amenities, including a restaurant, gift shop, flush toilets, camping, picnicking, dump station for motor homes, walking trails, and interpretive exhibits (cited in the State of Alaska's Trails and Recreational Access for Alaska Highway Corridor Assessments, NRCS 2004). Riverbank erosion has, and will continue to threaten the historic site and buildings at the Park (Figure 2).

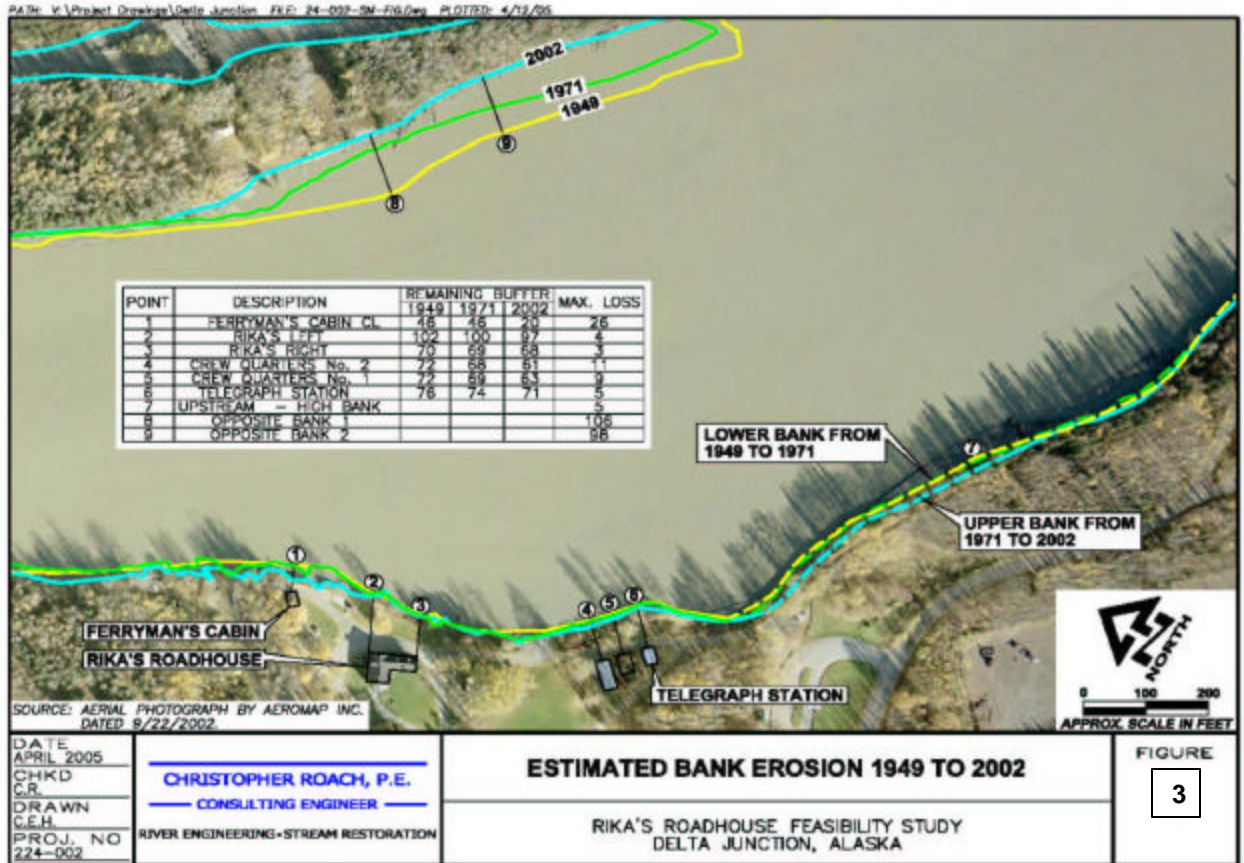
The most significant land loss has occurred just downstream from Rika's Roadhouse near the Ferryman's cabin and boat launch (between Points 1 and 2 - Figure 3). Treatment of this 220' section would involve reconstructing the bank by constructing a bankfull bench using root wads to buttress the upper slope, placing a riprap apron under the root wads at the toe of the slope, and reinforcing the root wads and rocks placed above the root wads with an organic slurry. Root wad bowls would be anchored into the bank with the root mass extending into the river and over the reinforced toe (see Appendix B – Conceptual Design for more details). This more aggressive approach would help to restore the bank to its pre-erosion position before the 1997 high water event and would allow an increased buffer to be established between existing structures and the restored edge of the bank.

Between points 2 and 3 on Figure 3, small riprap was placed in the toe of the bank in the 1950's by the military. That part of the bank has been stable for over 50 years and does not need to be restored.

In areas with minor erosion a variety of techniques would be used to stabilize the bank in place and allow existing vegetation to regenerate. Between points 3 and 4, Figure 3, coir logs or soil wraps would be anchored into the bank to provide protection against entrainment and transport of soils at the base of the upper soil layer. Willow bundles would be placed above the coir logs in order to rapidly increase vegetation coverage and rooting density. Biodegradable Geofabric would be placed over exposed soils and re-seeded to provide rapid surface erosion protection with grass.

In order to correct bank erosion at the duck pond overflow area (halfway between points 3 and 4 on Figure 3), effluent from the pond would be drained through an outfall (i.e. French drain) designed to eliminate surface flow over the bank and allow free draining through the bank. This would prevent excess pore pressure buildup within the bank and improve integrity of the bank at that location.

In areas with no active bank erosion (Figure 3 between points 4 and 7), vegetation would be actively planted and managed to reduce the risk of future bank erosion.
